**PROPOSAL FOR ADMINISTRATIVE
NO FURTHER ACTION
ENVIRONMENTAL RESTORATION
SITE 88A, FIRING SITE: RANCH HOUSE
OPERABLE UNIT 1334**

August 1994

Prepared by
Sandia National Laboratories/New Mexico
Environmental Restoration Project
Albuquerque, New Mexico

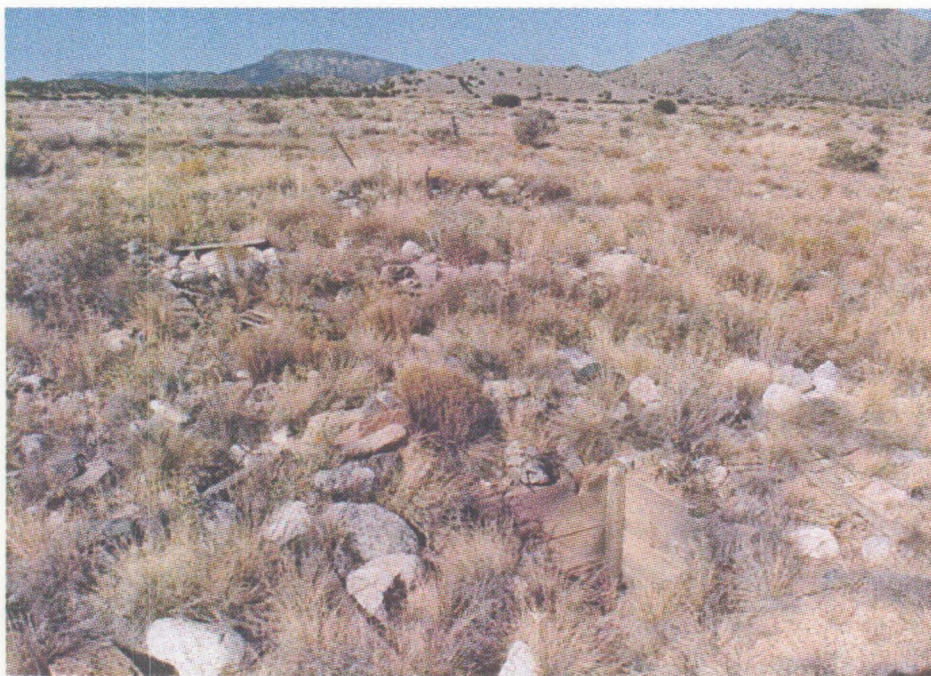
The concrete foundation of the former Ranch House is surrounded by cobble-sized rocks from which the structure was constructed. Pieces of wood believed to have been part of the building are found among the rocks. A 2-ft-deep wood-lined pit is located within the foundation and rubble area. According to interviews with former SNL/NM employees, this pitched-roof Ranch House consisted of two rooms with walls of field stone and mortar (62-29). In a 1963 SNL/NM drawing, this structure was referred to as the "Hacienda" and had the building number 9855 (88-22).

Remains of Ranch House, ER Site 88A. View to the northwest.

Aside from rubble and debris associated with the former Ranch House, there is no visual evidence at ER Site 88A indicating that the site contained hazardous waste or constituents.
